D*AP4 & D*AP8, all editions

Updating the system firmware

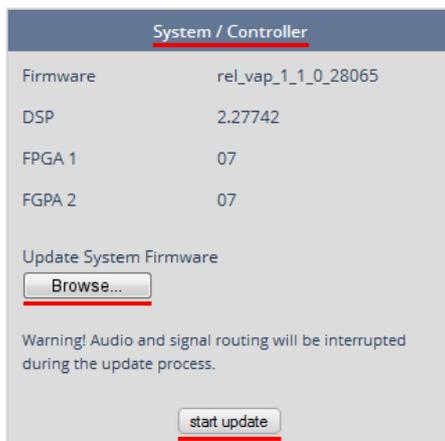
When updating the D*AP firmware, coming from an early version the system may regret recognizing the new firmware file as a valid version. A message may appear stating that the file is not suitable for this unit or the MD5 checksum is wrong. This is caused by a change in firmware structure and can be avoided by using an intermediate firmware file prior to updating to the final version.

2. On this page click on 'Browse...' in 'System/Controller' and locate the 'basic' firmware file.

Its designation may look like this (version number and device type may vary):

rel_map_2_7_4-basic-31521.img

It can be found in the 'Basic Firmware' subfolder inside the firmware zip.
